Quality Of Life Case Study

Helena Harris, Specialist Nurse Stoma Care, Abergavenny, Wales

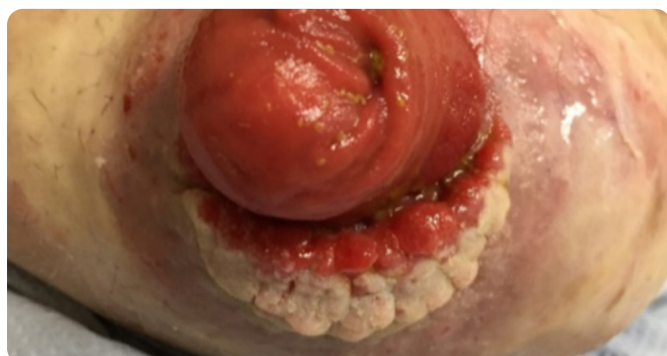
Photo 1: One week after using Dansac TRE seal and concave pouch

The following week, the patient felt that the pain around his stoma had reduced. He was pleased with the result of the intervention and was feeling happy and positive. He was still renewing the pouch daily as this made him feel more comfortable. On examination, I noted that the granulation tissue was much improved visually and he now had a DET score of 9. We agreed to continue using the Dansac TRE seal (Photo 1).

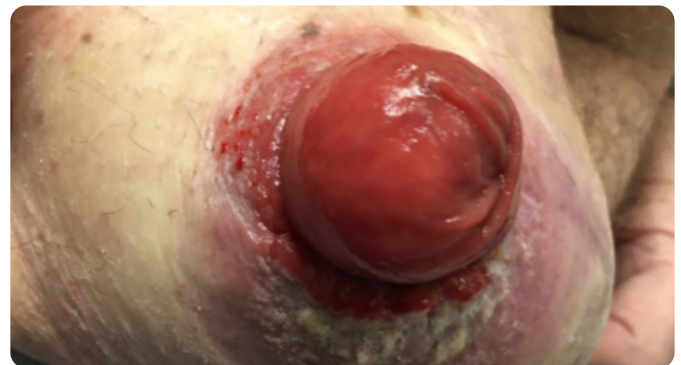
Photo 2: Discolouration to the left of the stoma

At his next clinic review, two weeks later, the patient's skin had visually improved further and his DET score was now 7. However, he had developed new sores to the right of his stoma, and the peristomal skin had begun to bleed. An area of discolouration was also noted to the patient's left of the stoma (Photo 2).

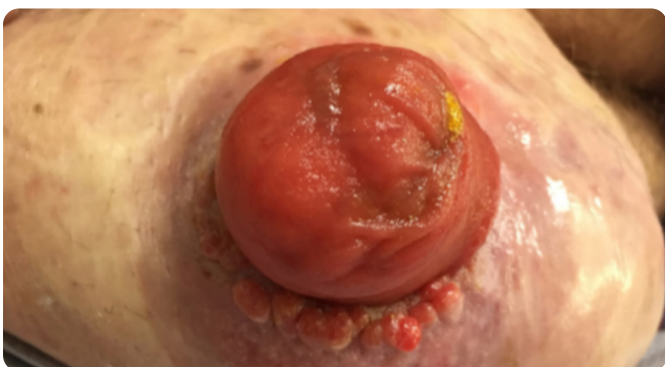
Photo 4: Three months post initial assessment showing visible improvement

Three months later, the granulation had greatly improved and the patient is managing well as part of an overall care plan (Photo 4). He is, however, still experiencing significant pain from the hernia and is currently awaiting an assessment by the surgical team.
